LITTLE CHOCONUT WATERSHED SITE 2C DAM

BROOME COUNTY, NEW YORK  
INVENTORY NO. NY, 722

**PHASE I INSPECTION REPORT  
NATIONAL DAM SAFETY PROGRAM**

**AUGUST 1981**

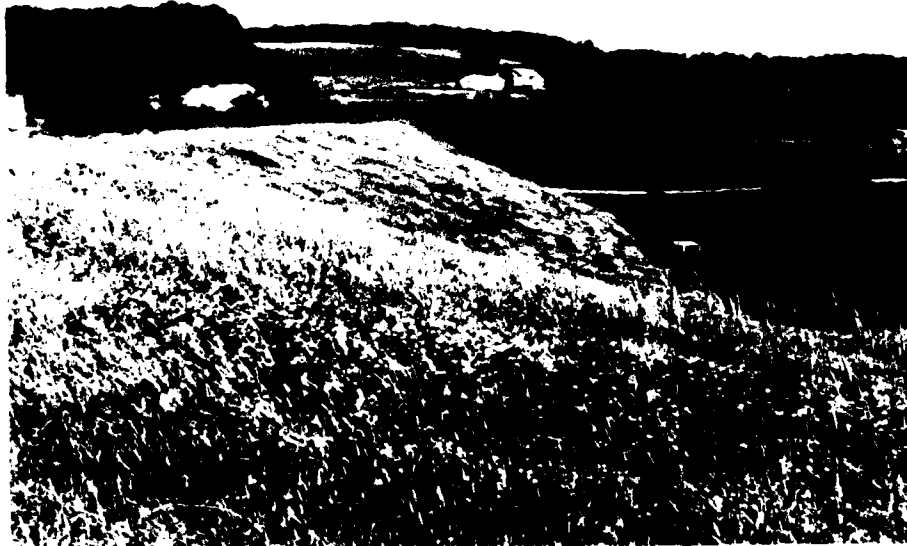
UPSTREAM SLOPE OF DAM

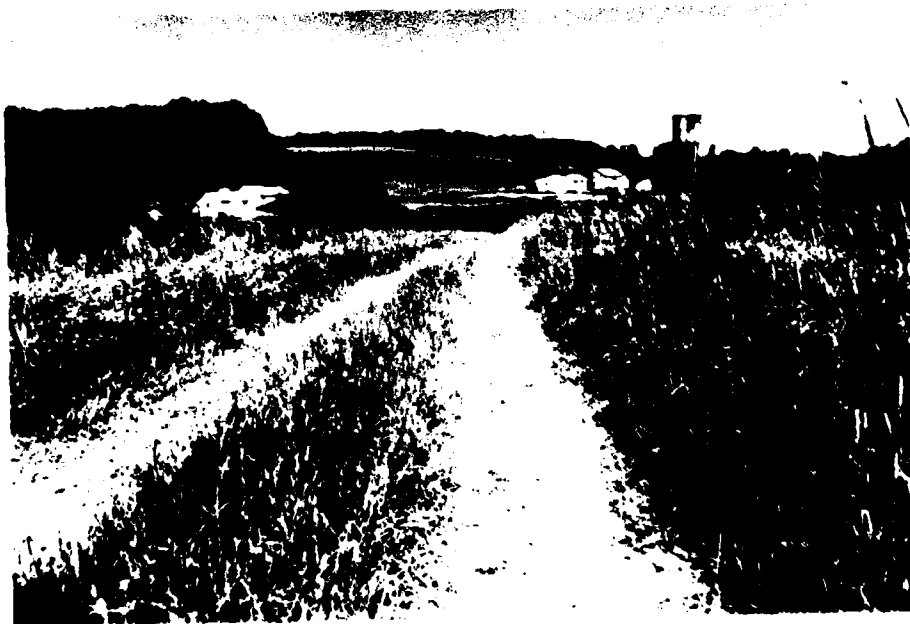
TOP OF DAM AND TIRE TRACKS

- (1) Vertical Alignment GOOD
- (2) Horizontal Alignment CURVED
- (3) Surface Cracks NONE
- (4) Miscellaneous TIRE TRACKS ALONG CREST

- a. Mow the crown vetch cover to facilitate future inspection evaluations.
- b. Repair areas eroded by vehicular traffic and consider methods to limit further trespass.
- c. Replace missing planking on top of the inlet riser.
- d. Lubricate the slide gate stem to insure continued operability.
- e. Repair the animal guard on the internal drainage pipe.
- f. Visually monitor the wet areas along the toe of the east side slope of the auxiliary spillway. If increased seepage causes instability of the slope, install horizontal drains into the hillside.
- g. Develop an emergency action plan for notification of downstream residents in the event of large auxiliary spillway discharges.
